Tookany Creek Watershed Management Plan

Visual Streambank Assessment

TOOKANY CREEK WATERSHED MANAGEMENT PLAN

Holy Sepulchre Cemetery to Abington Township Border

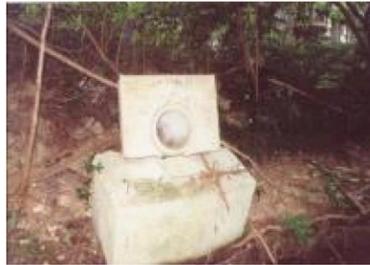
1. Dislodged/eroded drainage pipe behind Oak Summit Apartments (right bank)
Action/BMP: Repair stormwater pipe

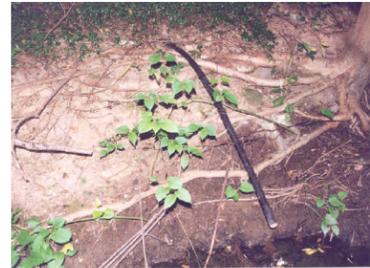
2. Unknown drainage pipe from Oak Summit Apts, possible drainage from indoor pool.
Action/BMP: Follow-up with the apartment management.

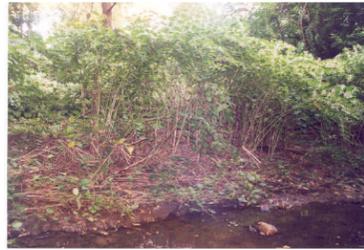
3. Spread of knotweed along left bank
Action/BMP: Develop eradication program for knotweed

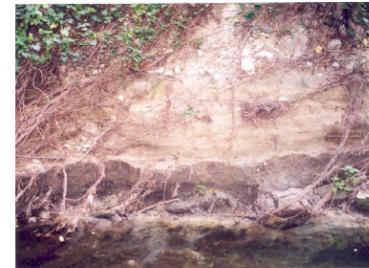
4. Vertical creek bank behind Oak Summit Apts., scouring of bank and undercutting
Action/BMP: Develop a plan for biotechnical streambank restoration

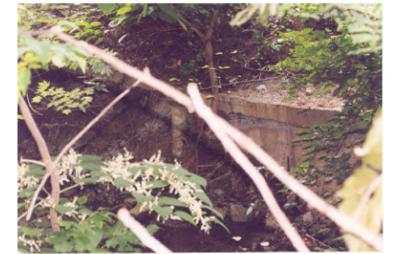
5. Broken concrete bulkhead
Action/BMP: Have the township engineer assess the problem and develop solution.

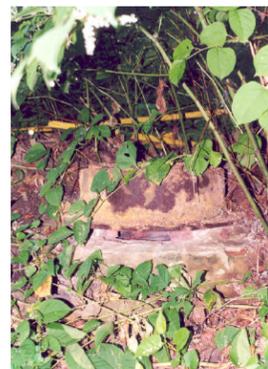
6. Broken/breached concrete collar of sanitary sewer
Action/BMP: Have the township engineer assess the problem and develop solution

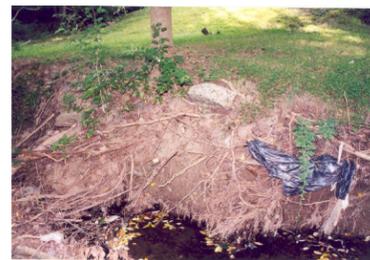
7. Erosion of streambank
Action/BMP: Develop a plan for biotechnical streambank restoration

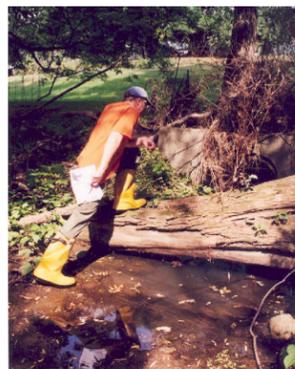
8. Discolored water & storm drain from General Patterson Drive
Action/BMP: Follow up on the source of the discharge.

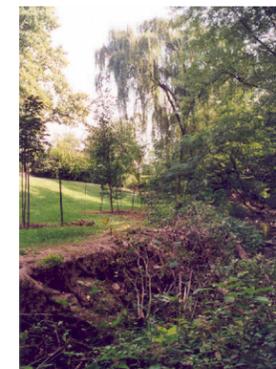
9. Stream bank erosion
Action/BMP: Develop a plan for biotechnical streambank restoration

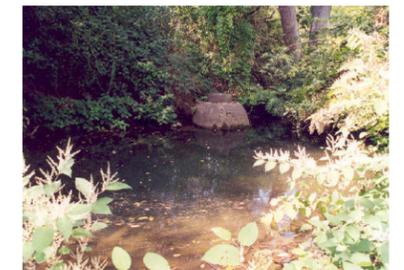
10. Discolored water in deep pool behind Kaname Gardens adjacent to Waverly Road
Action/BMP: Follow up with the nursery owner

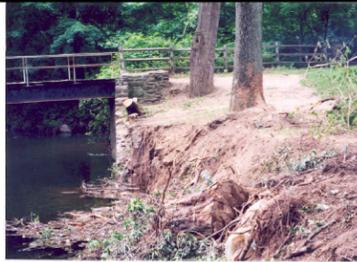
1. Pedestrian bridge at Jenkintown Creek shortly after Tropical Storm Allison (5/01). The surrounding area under the trees is routinely mowed to the bank.
Action/BMP : This area is currently undergoing biotechnical streambank restoration.

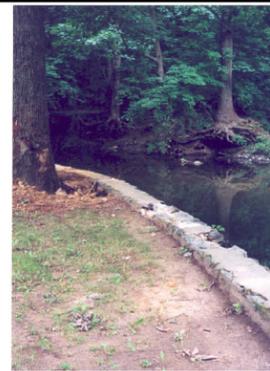
2. Typical mowed lawn up to the wall which prevents NPS pollution from being filtered by the riparian buffer and stabilizing the eroding channel bed
Action/BMP : Replant the understory of shrubs and herbaceous layer along walled areas of the Tookany Creek.

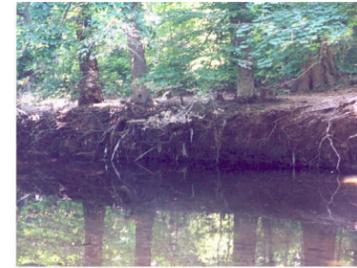
4. The steep wooded slopes of the west bank of the Tookany Creek along the Parkway are becoming undercut as a result of the upstream volumes of stormwater. The mature trees can hold the bank with their roots, but if the volume of water continues, the roots will be undermined and the trees will fall.
Action/BMP : Conduct a complete study of the hydrology of the Tookany Creek using the Rosgen model to develop a long-term plan for the restoration. Use biotechnical streambank restoration to fortify the roots and stabilize the banks.

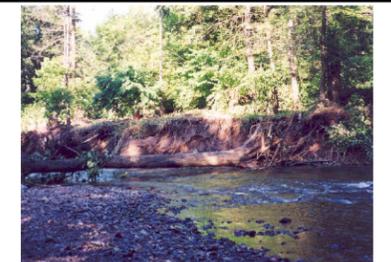
5. Newly eroded banks as a result of Tropical Storm Allison.
Action/BMP : This area is undergoing biotechnical streambank restoration. Continue to monitor for knotweed re-infestation.

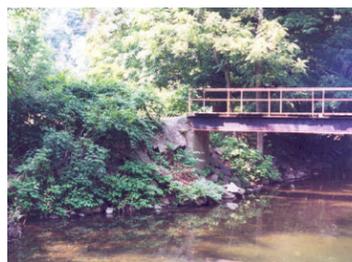
6. Japanese knotweed, an invasive, non-native plant, is the most common plant species along Tookany, replacing the native vegetation. It is very difficult to permanently get rid of.
Action/BMP : Develop an invasive species program to remove the knotweed and replace with native vegetation

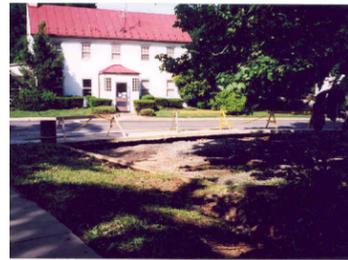
7. This intersection continually floods during storm events. This picture shows the severe damage to the road after Tropical Storm Allison in 2001.
Action/BMP : Conduct a complete study of the hydrology of the Tookany Creek using the Rosgen model to develop a long-term plan for the restoration.

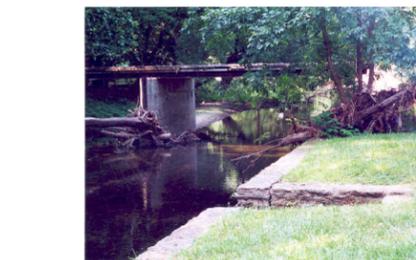
10. The area adjacent to the Tookany Parkway and the creek is mowed to the banks, preventing any filtering of the NPS pollution.
Action/BMP : The golf course and the township should revise the mowing practices to less area and frequency. Plant the understory with native shrubs and herbaceous layer to fortify the riparian buffer.

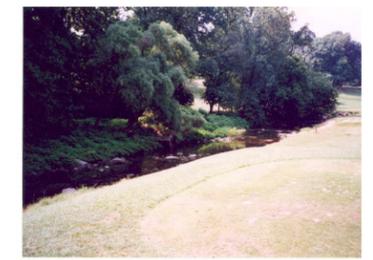
11. Melrose Golf Course maintains the grass to the creek bed, preventing any riparian filtration of NPS pollution.
Action/BMP : Encourage participation in the Audubon certification program for golf courses. Possibly reduce the greens directly next to the Tookany Creek and replant with native vegetation to filter NPS pollution and stabilize the banks.

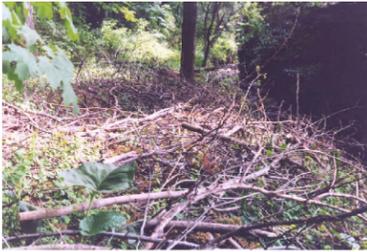
2. Baeder Creek piped under a garage and then under Abington Rd. /Ghost Rd. No water before pipe, on other side of road, water begins to flow. Three storm drains come together under road. For a long stretch, the stream is walled on one side (wood and stone). Other side 50% slope. Lots of brush thrown near stream bed from adjacent properties.

Action/BMP: Homeowner Education program; form local resident creek group to conduct routine clean-ups.

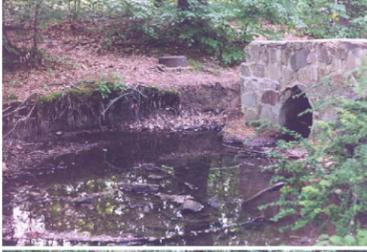
3. Wall on one side continues no slope, straight down on the other side. Small Foot Bridge crosses stream. Two mallard ducks on the stream.

Action/BMP: Stop mowing to the creek banks; Employ Biotechnical streambank techniques to restore bank to a more natural 3:1 slope and replant with native vegetation.

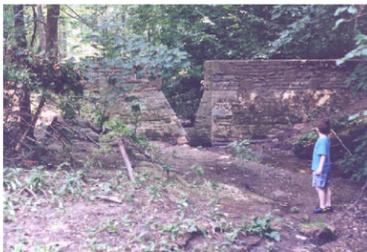
4. Baederwood Park near the creek with foot bridge. Stream widens to 15ft. Small wetland area as indicated by obligate plant species of skunk cabbage. Water clear. Slope 20% on one side, other side wetlands then gradual slope. Under cutting around foot bridge.

Action/BMP: Employ biotechnical streambank techniques to restore bank. After bridge, stream widens considerably in a spot. Bank really cut on side of playground. Action/BMP: Employ biotechnical streambank techniques to restore and stabilize bank.

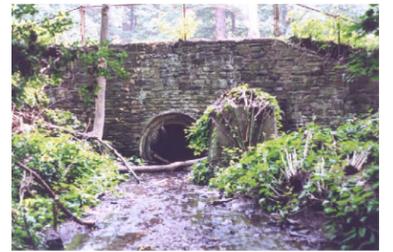
5. Attractive stone wall across the creek, 20 ft high 3ft. gap cut into it - possibly used to slow down water flow. Several mature beech trees, maples, tulip, and oak. A great deal of in-channel erosion.

Action/BMP: Employ Biotechnical streambank techniques to restore bank to repair channel erosion and bring the banks to more natural 3:1 slope and replant with native vegetation

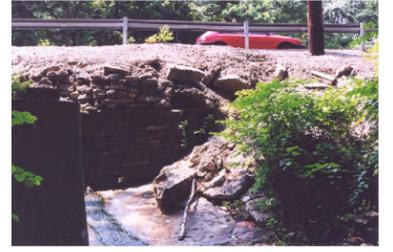
6. Creek flows under Highland Ave. Sewer line in creek bed, undercut. Lots of Knotweed.

Action/BMP: Have Abington Township engineer evaluate sewer line stability and consider biotechnical streambank techniques to repair bank and remove the knotweed with native plants simultaneously.

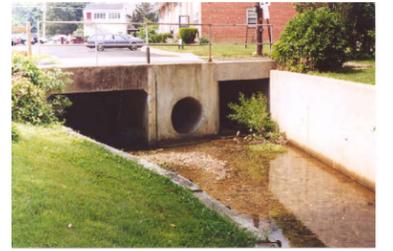
11. After flowing under Baeder Road, the stream is walled in on both sides. Walls vary in height from 6 to 12 feet in spots. The vertical wall is 6x6 lumber most of the way. Along part of the creek, the wall is cement.

Action/BMP: Consider removing the walls and employ biotechnical streambank techniques to restore riparian buffer and its essential functions, and allow the bank to become a more natural 3:1 slope and replant with native vegetation.
