Tookany Creek Watershed Management Plan

Visual Streambank Assessment

TOOKANY CREEK WATERSHED MANAGEMENT PLAN

Holy Sepulchre Cemetery to Abington Township Border

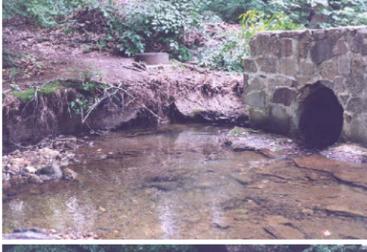
4. Baederwood Park near the creek with foot bridge. Stream widens to 15ft. Small wetland area as indicated by obligate plant species of skunk cabbage. Water clear. Slope 20% on one side, other side wetlands then gradual slope. Under cutting around foot bridge.

Action/BMP: Employ biotechnical streambank techniques to restore bank. After bridge, stream widens considerably in a spot. Bank really cut on side of playground. Action/BMP: Employ biotechnical streambank techniques to restore and stabilize bank.

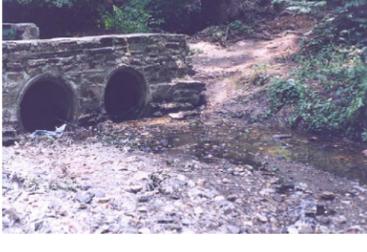
3. Wall on one side continues no slope, straight down on the other side. Small Foot Bridge crosses stream. Two mallard ducks on the stream.

Action/BMP: Stop mowing to the creek banks; Employ Biotechnical streambank techniques to restore bank to a more natural 3:1 slope and replant with native vegetation.

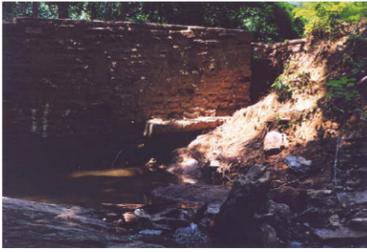
5. Attractive stone wall across the creek, 20 ft high 3ft. gap cut into it - possibly used to slow down water flow. Several mature beech trees, maples, tulip, and oak. A great deal of in-channel erosion.

Action/BMP: Employ Biotechnical streambank techniques to restore bank to repair channel erosion and bring the banks to more natural 3:1 slope and replant with native vegetation

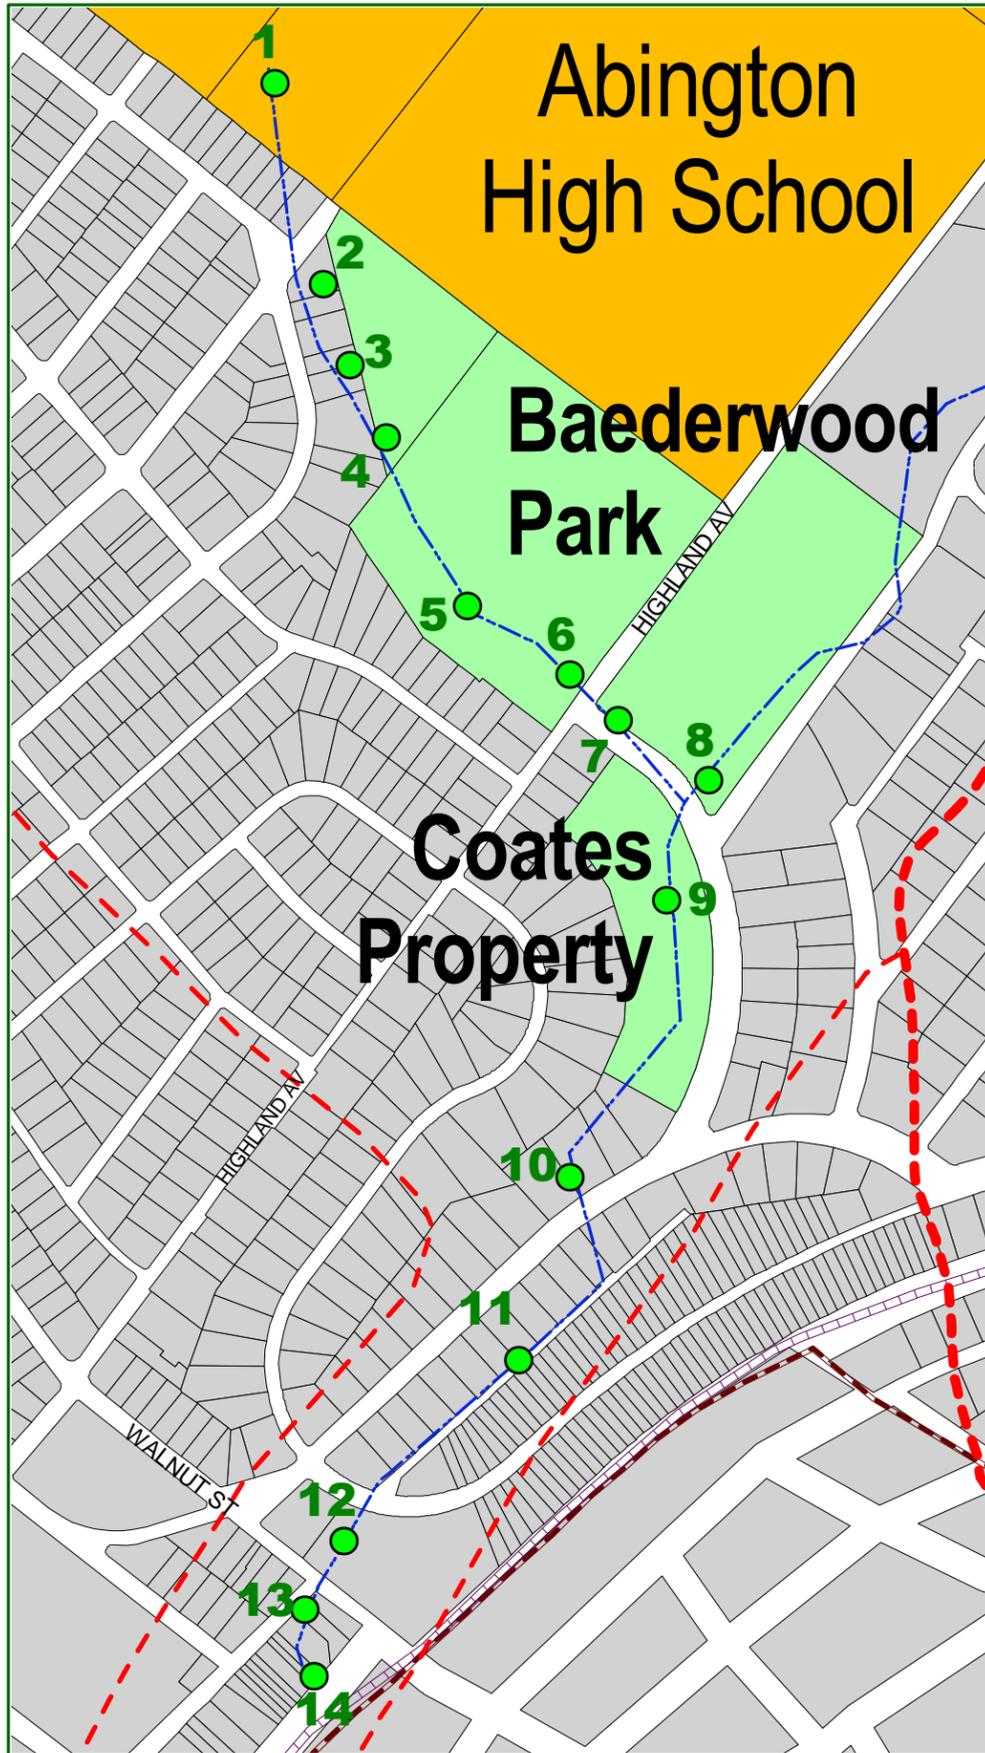
6. Creek flows under Highland Ave. Sewer line in creek bed, undercut. Lots of Knotweed.

Action/BMP: Have Abington Township engineer evaluate sewer line stability and consider biotechnical streambank techniques to repair bank and remove the knotweed with native plants simultaneously.
