Township of Cheltenham

Board of Historical and Architectural Review

GUIDELINES FOR EXTERIOR MAINTENANCE

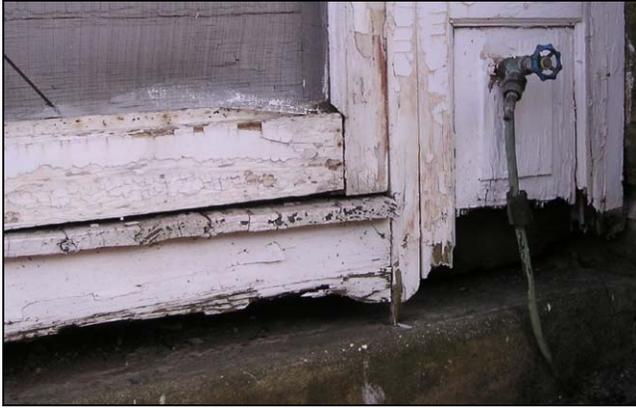
The wood base is in contact with the concrete foundation. Regular wood dampness can eventually lead to rot and deterioration.

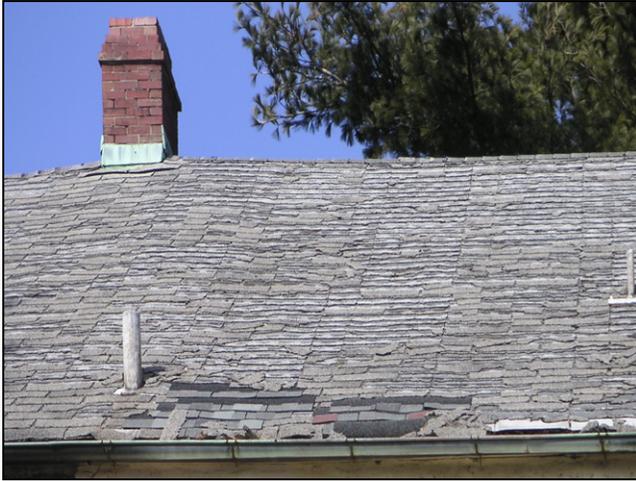
The mineral granules on the asphalt shingles have almost completely worn away. Portions of shingles have broken off and can be found in the gutters and on the ground. Prior patching is evident at the edge of the roof. The top of the roof curves down from the chimney, a possible indication of a structural problem.

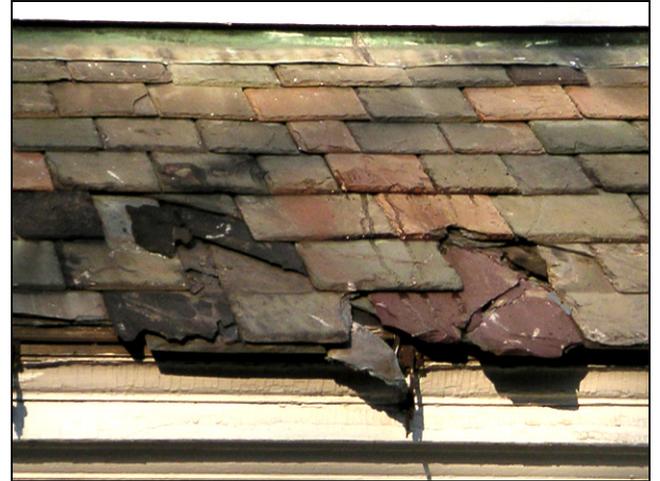
Slates are cracked, dislodged and missing. Some of the surfaces are delaminating. Approximately 25 to 30 percent of the slates on this roof are either missing or damaged. Given the pervasiveness of the problems, considering roof replacement would be appropriate.

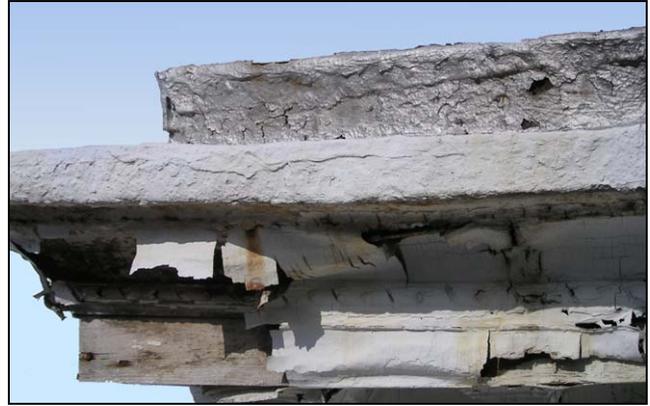
Peeling paint adjacent to roof edges is often an indication of roof draining problems or potential leaks. Bare wood is more susceptible to rot and deterioration. Proper preparation prior to repainting is recommended.

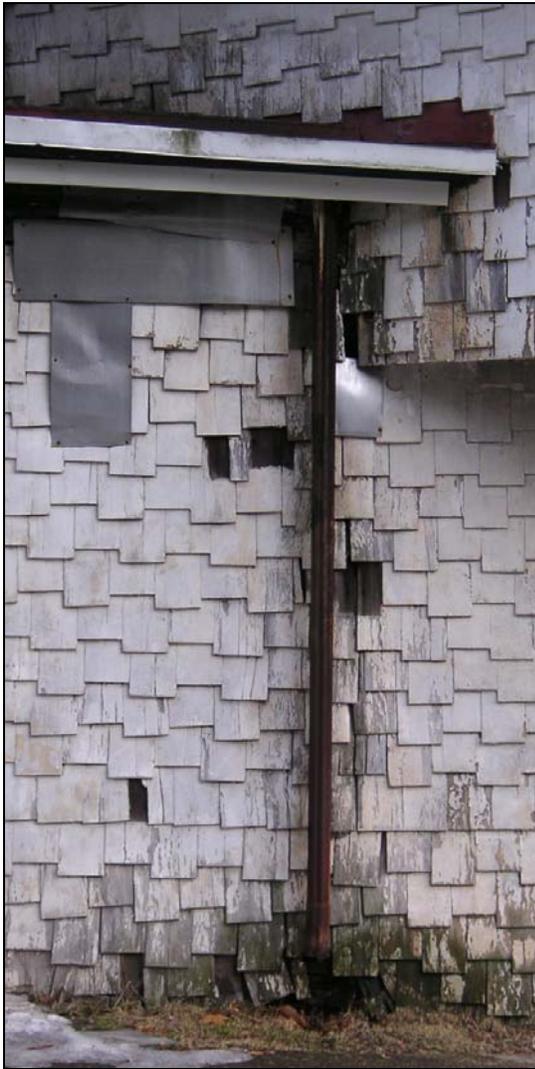
Problems with the gutter and downspout have resulted in deterioration of the wood shingles. Sheet metal patches suggest missing or deteriorated shingles and the staining adjacent to the ground that the water collected through the downspout is not being directed away from the foundation.

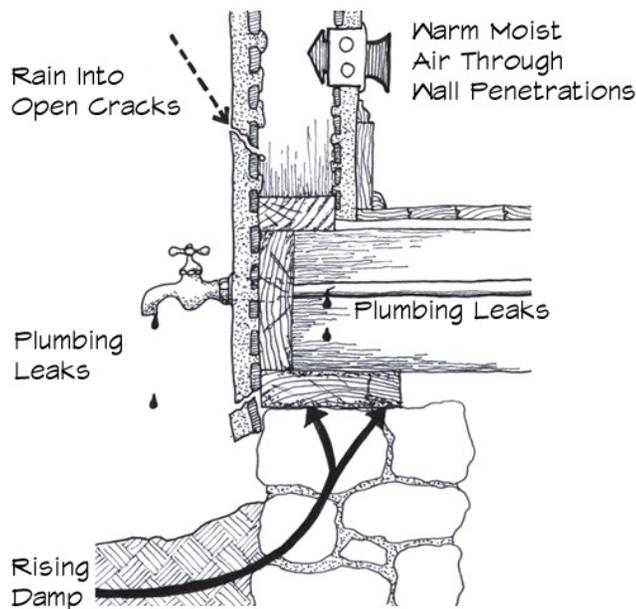
Rain and Precipitation can enter the exterior envelope through damaged surfaces, small cracks in the surfaces and crevices with adjacent materials including window and door frames.

Rising Damp is the migration of moisture from the soil into the building structure through capillary action. The soil adjacent to the foundation can become saturated through improper drainage from gutters and downspouts and vegetation planted adjacent to the foundation.

Plumbing Leaks include piping as well as bathroom fixtures, kitchen and laundry appliances, and underground piping.

Condensation occurs when warm moist air from bathrooms, kitchens and laundry facilities comes in contact with cold surfaces and changes to water droplets.

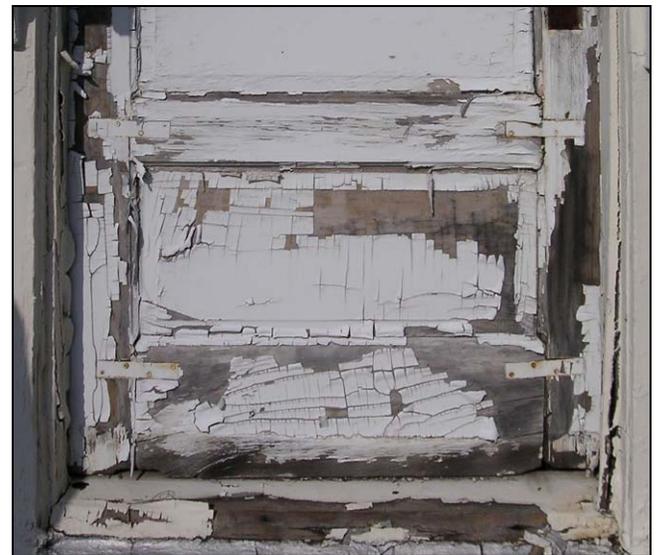
The paint on this door has alligatored, and severe cracking is visible. Removal of paint down to bare wood and proper door repair is recommended prior to repainting
